Annex B

Summary Reports of S19 Investigations

Staines-Upon-Thames

Wheatsheaf Lane and Penton Hook Lane, Enquiry Reference: 100713

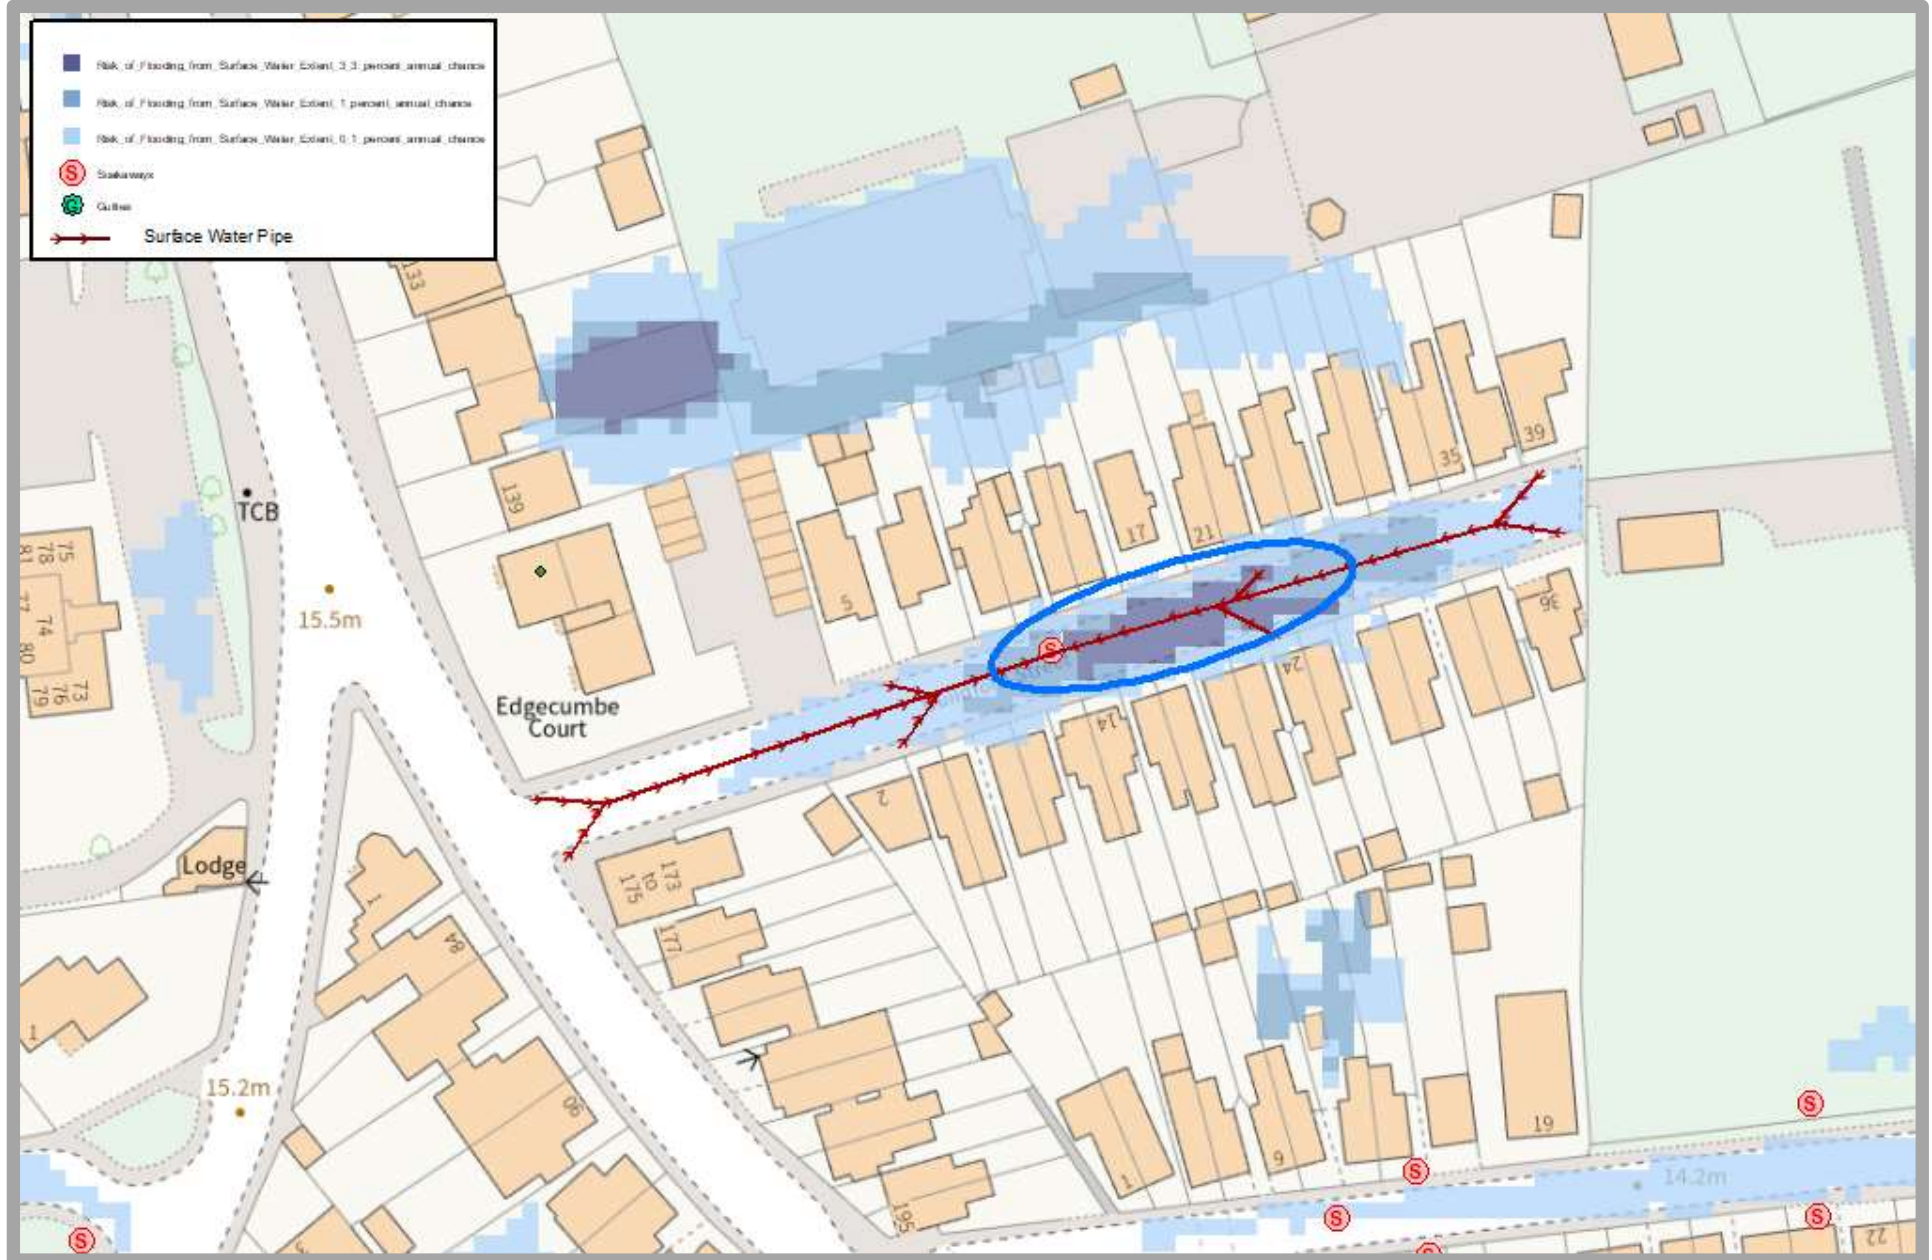
Flood Summary Map

The main source of the flooding comes from the rising groundwater, which first begins infiltrating into the foul sewer and, as the groundwater levels rise, backs up out of the soakaway and highway gullies, flooding the road. With the surface water drainage unable to function, all additional surface water reaching the location exacerbates the existing flood on the highway.

Major flooding of the highway occurred as water seemed to discharge out of the highway gullies and the extent of this flooding closely matched what is shown by the surface water flood risk maps. This restricted vehicle access to the properties on the eastern half of Guildford Street and some of the footway was flooded on the south side at the lowest point. Some front gardens were partially flooded but no internal property flooding was reported. The properties along Guildford Street, as well as some in Edgumbe Court, lost access to foul services during the flood event, as the groundwater rose and began infiltrating into the foul main.

- Lining the main foul system along Guildford Street to reduce infiltration from groundwater and make foul services more resilient to future groundwater flooding.
- Monitor the effects of groundwater on the foul system after it has been lined.

- Surrey Highways to check gullies after a flood event and record silt levels – this is needed to differentiate between blockages and periods of high groundwater.
- Surrey Highways to arrange parking suspensions ahead of cyclic gully cleaning to ensure are gullies are accessible.

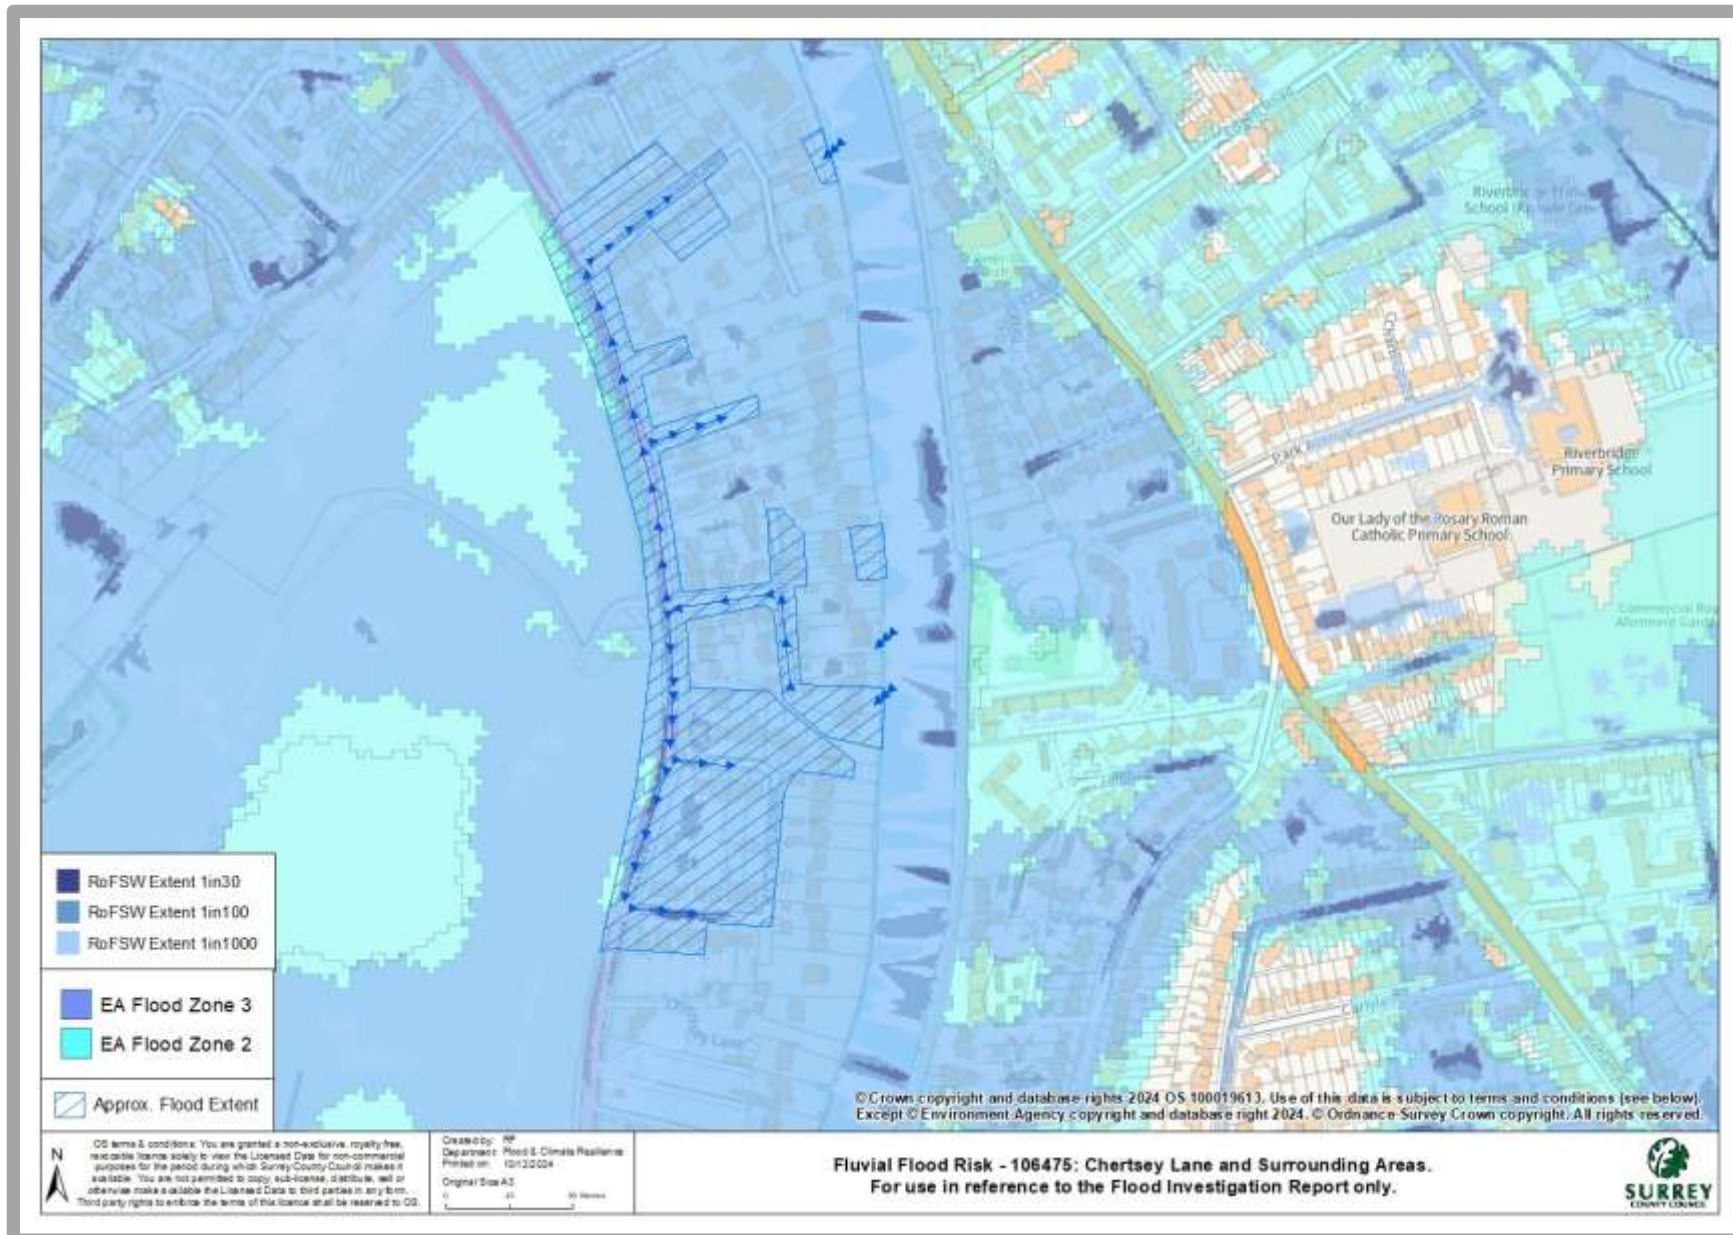
Flood Summary Map

Some properties back onto the River Thames and were affected directly by rising river levels. However, many residents at Mayfield Gardens, Timsway, and Chertsey Lane were affected by flooding from Chertsey Lane. The river broke bank at a low section of bank at Bundys Way, subsequently flooding Chertsey Lane, Mayfield Gardens, and Timsway.

- May consider examine the opportunities to identify impacts of the flood path which originates at a low point in Bundys Way.
